**CANADIAN FORCES
FLIGHT SAFETY INVESTIGATION REPORT**

FILE NUMBER: 1010-N546PA

AIRCRAFT TYPE: Lear 36A

LOCATION: Astoria Regional Airport, Oregon

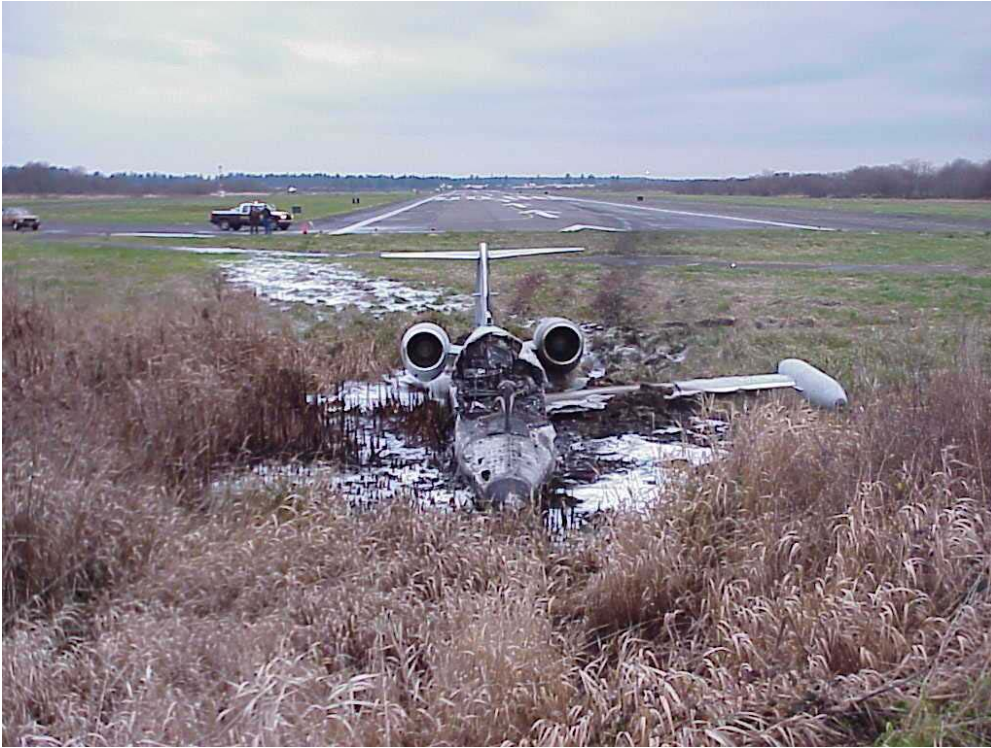
Photo 1: Final resting place

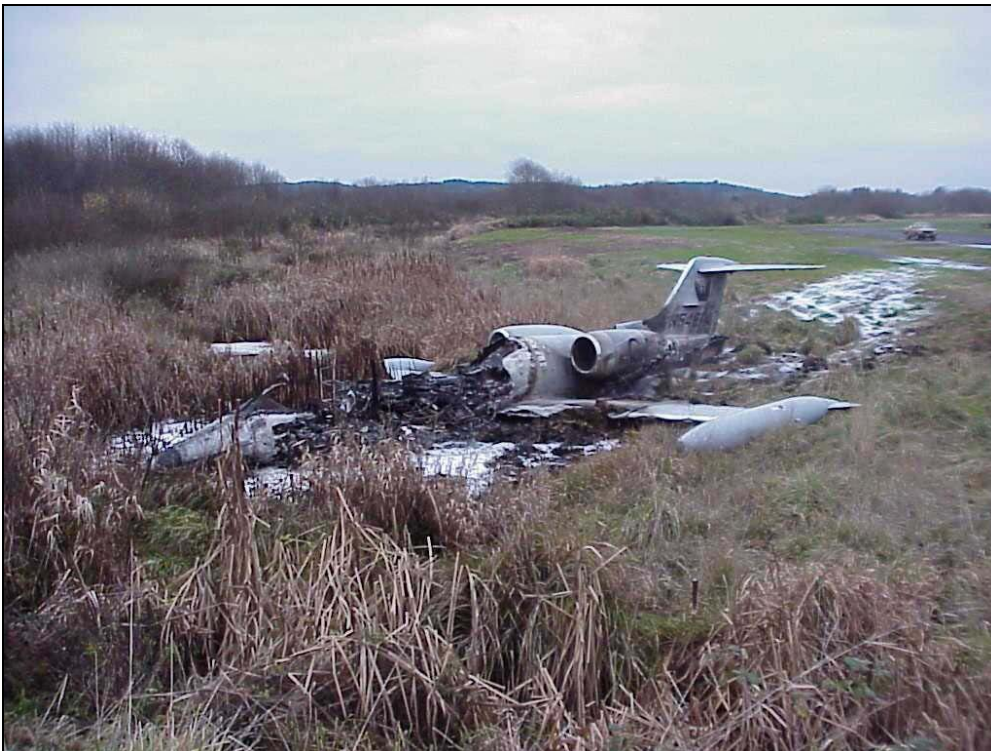
The aircraft received A Category damage (see photos). The impact with the elk damaged the left wing just inboard of the mid-span point and ruptured the wing fuel tanks. The leaking fuel was ignited by the left engine. The drag chute was deployed and was ignited by the fire. After the aircraft came to rest past the end of the runway, the fuel fed fire consumed most of the fuselage, from the nose to the engine intakes.

Photo 2: Fuselage damage

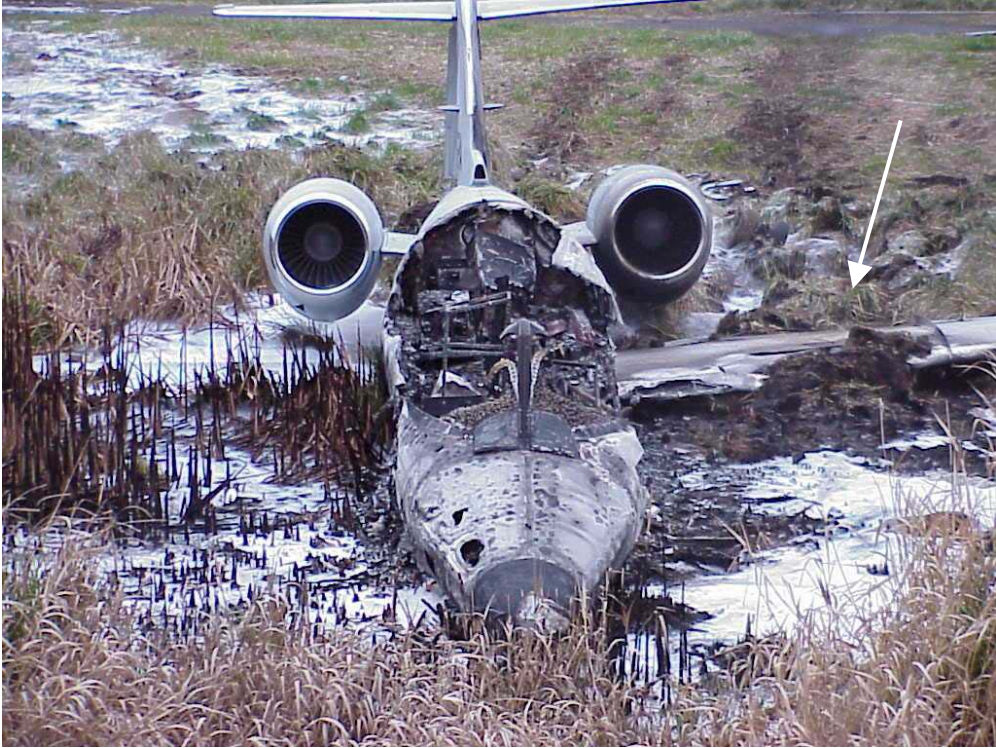
The collision with the elk caused substantial damage to the leading edge of the left wing and may have seriously damaged the main spar (see photo 3). It is uncertain if the wing would have been able to support the weight of the aircraft had the crew elected to continue the take-off since they were past V1. The fuel tank was ruptured and fuel spilled into the air stream and onto the left engine. This fuel was ignited by the engine and continued to burn as the aircraft decelerated. The fire intensified after the aircraft came to a stop past the end of the runway. The post crash fire completely destroyed the cabin and cockpit areas.

Photo 3: Elk impact point

Part of the airport property is already fenced. The final portion of the fence had already been approved and funded before the accident and will be erected in the spring. This fence should now fully enclose the airport and prevent any further elk incursion.
